# Design Guidelines

## Ambridge Historic District Ambridge, Pennsylvania

### Borough of Ambridge Historical Architectural Review Board

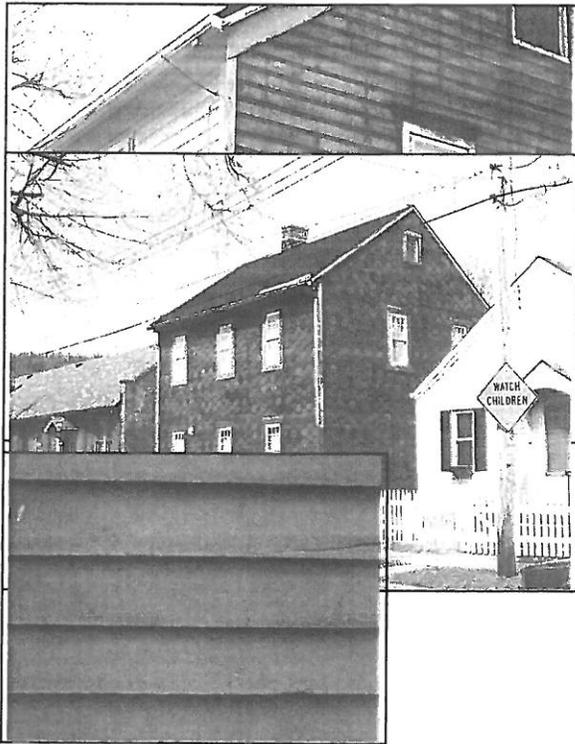
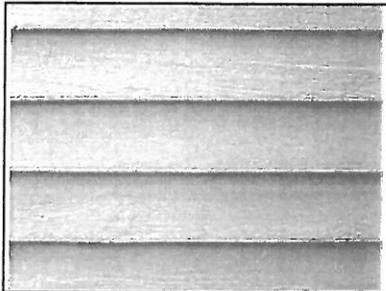
Above are the three traditional forms of wood siding which are found on Harmonist buildings throughout the Ambridge Historic District. From left to right, the styling styles are *weatherboard*, *beaded weatherboard*, and *shiplap*. Siding replacement projects for Harmonist buildings should be confined to one of these forms.

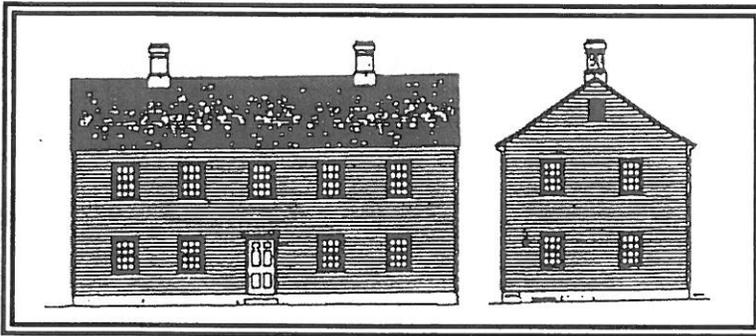
**Two-Story Frame Double House**

story frame houses.

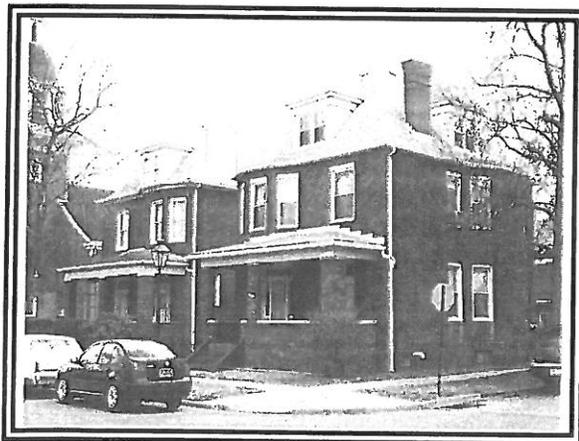
Likely the most common American house type of the first forty years of the twentieth century the houses are basically square in plan two or two-and-one-half stories in height and are usually capped with hipped roofs with dormers. They typically have a one-story front porch, also with a hipped roof. Occasionally, Foursquares appear with art glass windows.
